AutoGyro Certification Ltd Service Bulletin (Permit)

Title: Calidus upper mast bracket replacement		Release date 30.03.2022
SB-145 Iss1	Related documents Modification: MC-439 CCAR No.: None	Compliance Category:
Applicability		OPTIONAL or RECOMMENDED or MANDATORY
Aircraft type & model: Calidus	Aircraft serial Nos. affected: As required, optional	
The maintenance manual to be referenced is this stated or subsequent issue.		None
<p>This form is the response from AutoGyro Certification Ltd either against a problem found in the product in service requiring a containment or rectification action, or as service information for aircraft modification incorporation. For help, contact RotorSport on 44(0)1588 505060, or email compliance@rotorsport.org.</p> <p>The technical content of this document is approved under the authority of the UK CAA Design Organisation Approval Ref: DAI/9917/06</p>

Title: Calidus mast bracket replacement		
AG-SB-2022-01-C-EN	Effective Date: 05 APR 2022	Compliance Category:
Applicability		A - MANDATORY B - RECOMMENDED C - OPTIONAL
Aircraft type & model: Calidus	Affected Serial number(s): All; aftermarket repair	
The maintenance manual to be referenced is this stated

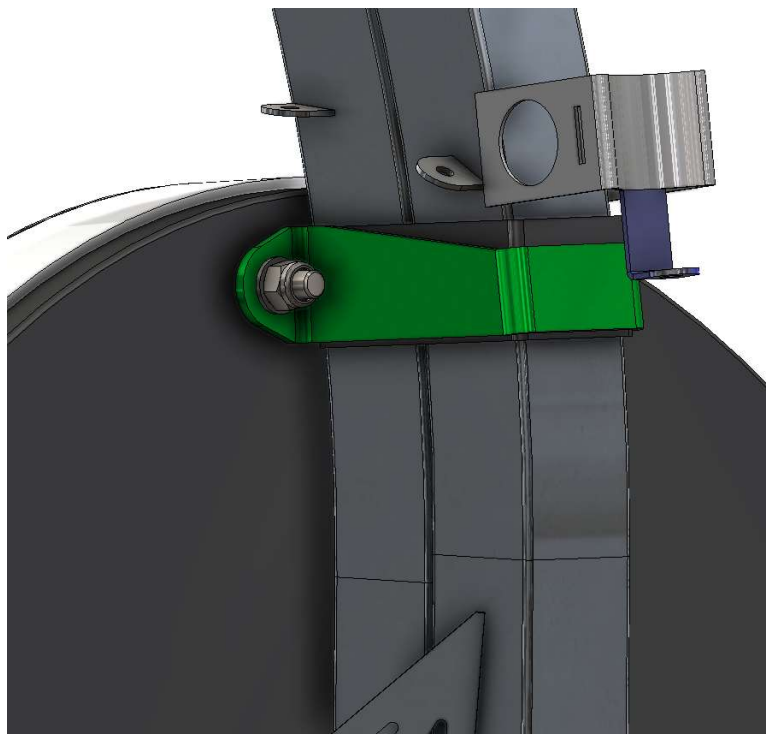
In response to occasional reports of both a crack in the upper mast to body mounting bracket or forward mast in the same area, AutoGyro has developed a repair method to replace the upper mast to body mounting bracket with a separate bracket. This allows mast flexure whilst still providing a secure fixing to the front body.

Solidworks view of the improved attachment between the mast and body.
