RotorSport UK Ltd Service Bulletin (Permit)

Title: Calidus Control cable clamps		
SB-104 Iss1	Related documents Modification: MC-329 CCAR No.: None	Compliance Category: OPTIONAL or RECOMMENDED or MANDATORY
Applicability		
Aircraft type & model: Calidus	Aircraft serial Nos. affected: RSUK/CALS/any	
The maintenance manual to be referenced is this stated or subsequent issue.		RSUK0061 Iss6
<p>This form is the response from RotorSport UK Ltd either against a problem found in the product in service requiring a containment or rectification action, or as service information for aircraft modification incorporation. For help, contact RotorSport on 44(0)1588 505060, or email compliance@rotorsport.org.</p> <p>The technical content of this document is approved under the authority of the UK CAA Design Organisation Approval Ref: DAI/9917/06</p>

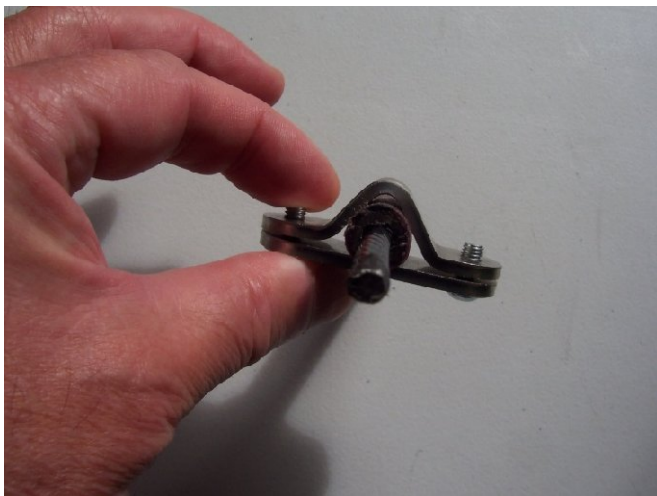
Fig 2 Control cable clamp

Under certain circumstances operating clearances in the push-pull control cables (used for pitch and roll control) can allow the transmission of rotor vibration to the control stick. Fitment of these clamps enables the clearance to be adjusted and the vibration reduced (See Fig 2).
