RotorSport UK Ltd Service Bulletin (Permit)

Title: Ivoprop motor controller software update		Release date 1st Dec 2018
SB-131 Iss1	Related documents Modification: MC-407 CCAR No.: CCAR-064, 66, 70	Compliance Category: OPTIONAL or RECOMMENDED or MANDATORY
Applicability		
Aircraft type & model: Any RotorSport AutoGyro gyroplane fitted with an Ivoprop propeller.	Aircraft serial Nos. affected: Any RotorSport AutoGyro gyroplane fitted with an Ivoprop propeller.	
The maintenance manual to be referenced is this stated or subsequent issue.		MTOsport RSUK0044 Iss 9 Calidus RSUK0061 Iss 7 Cavalon RSUK0288 Iss 5 MTOS2017 RSUK0396 Iss 1
<p>This form is the response from RotorSport UK Ltd either against a problem found in the product in service requiring a containment or rectification action, or as service information for aircraft modification incorporation. For help, contact RotorSport on 44(0)1588 505060, or email compliance@rotorsport.org.</p> <p>The technical content of this document is approved under the authority of the UK CAA Design Organisation Approval Ref: DAI/9917/06</p>

Title: Ivoprop motor controller software update		
AG-SB-2018-07-B-EN		Compliance Category:
Applicability		A – MA

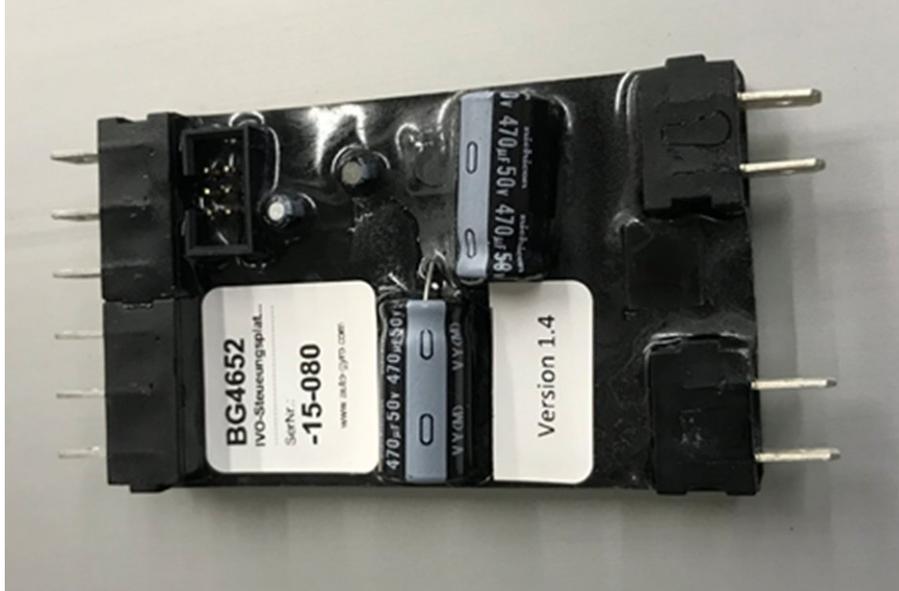
Photo of the Control Board

The Ivoprop pitch change motor has suffered from poor service reliability. Analysis of the motor current draw during the propeller operating cycle has identified peak current loadings that are a major contributory factor. These are significantly reduced by modified 'soft start' software in the propeller controller module.

1. Locate the Control Board module (see photo), which is located behind the instrument panel (or under the front seat on MTOS). On some aircraft this may be easily accessible without removing the panel, on others the panel must be detached from the aircraft and pulled rearwards to give access.
2. Disconnect the supply cables to the control board.
3. The Control Board will be secured either by Velcro or zip ties, or possibly adhesive. Remove the Control Board.
4. Fit the new Control Board, secure, and reconnect the cables.
5. Refit the panel if detached and check all fastenings secure.
6. In a safe area, turn on the aircraft keyswitch to power the aircraft systems.
7. Operate the propeller pitch change switch from full fine to full coarse and back to full fine 5 times. Ensure the function is normal.
8. Complete the aircraft logbook entries.

1. Locate the Control Board,
2. Connect the upgrade equipment
3. Reflash the program. Remove the equipment.
4. Mark the Control Board module with the new software level v1.5

5. In a safe area, turn on the aircraft keyswitch to power the aircraft systems.
6. Operate the propeller pitch change switch from full fine to full coarse and back to full fine 5 times. Ensure the function is normal.
7. Complete the aircraft logbook entries as market applicable.

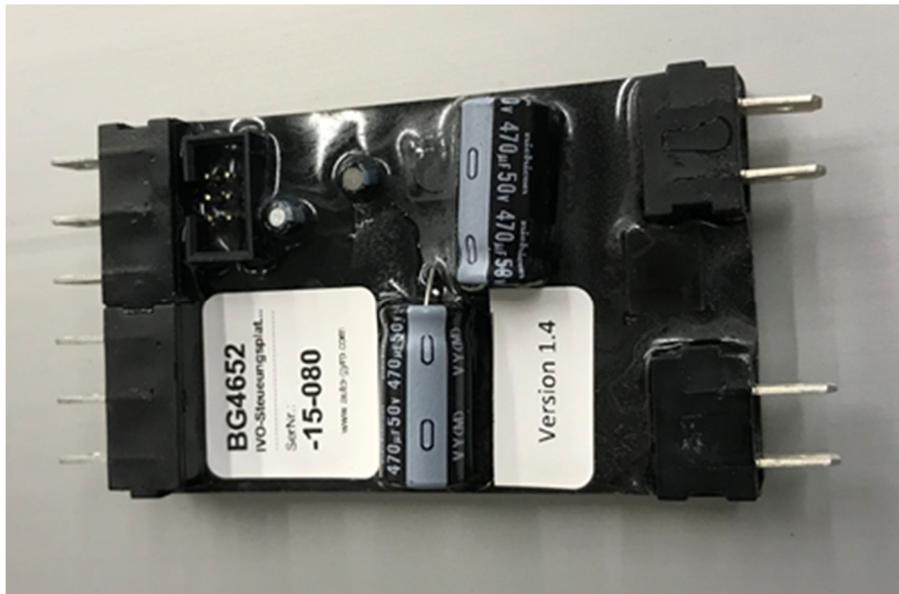
Photo of the Control Board.

The Ivoprop pitch change motor has suffered from poor service reliability. Analysis of the motor current draw during the propeller operating cycle has identified peak current loadings that are a major contributory factor. These are significantly reduced by modified 'soft start' software in the propeller controller module.

1. Locate the Control Board module (see photo), which is either located on the left side of the forward seat (MTO Sport) or behind the instrument panel. On some aircraft this may be easily accessible without removing the panel, on others the panel must be detached from the aircraft and pulled rearwards to give access.
2. Disconnect the supply cables to the control board.
3. The Control Board will be secured either by Velcro or zip ties, or possibly adhesive. Remove the Control Board.
4. Fit the new Control Board, secure, and reconnect the cables.
5. Refit the panel if detached and check all fastenings secure.

6. In a safe area, turn on the aircraft keyswitch to power the aircraft systems.
7. Operate the propeller pitch change switch from full fine to full coarse and back to full fine 5 times. Ensure the function is normal.
8. Complete the aircraft logbook entries as market applicable.

1. Locate the Control Board,
2. Connect the upgrade equipment
3. Reflash the program. Remove the equipment.
4. Mark the Control Board module with the new software level v1.5
5. In a safe area, turn on the aircraft keyswitch to power the aircraft systems.
6. Operate the propeller pitch change switch from full fine to full coarse and back to full fine 5 times. Ensure the function is normal.
7. Complete the aircraft logbook entries as market applicable.
