RotorSport UK Ltd Service Bulletin (Permit)

Title: Calidus Control cable clamps		
SB-104 Iss1	Related documents Modification: MC-329 CCAR No.: None	Compliance Category: OPTIONAL or RECOMMENDED or MANDATORY
Applicability		
Aircraft type & model: Calidus	Aircraft serial Nos. affected: RSUK/CALS/any	
The maintenance manual to be referenced is this stated or subsequent issue.		RSUK0061 Iss6
<p>This form is the response from RotorSport UK Ltd either against a problem found in the product in service requiring a containment or rectification action, or as service information for aircraft modification incorporation. For help, contact RotorSport on 44(0)1588 505060, or email compliance@rotorsport.org.</p> <p>The technical content of this document is approved under the authority of the UK CAA Design Organisation Approval Ref: DAI/9917/06</p>

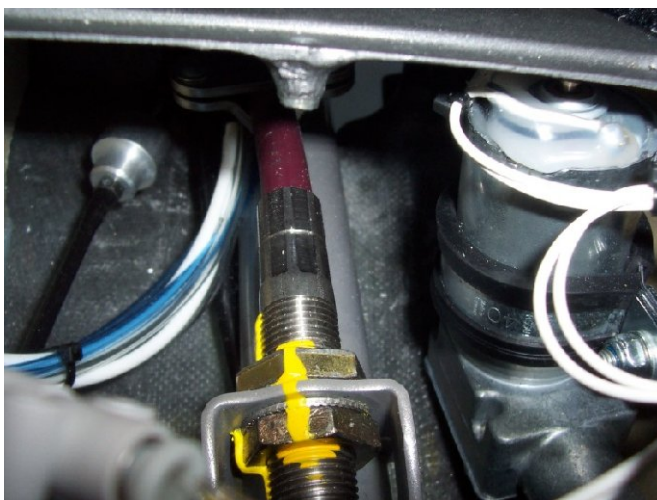
Fig 2 Control cable clamp

Under certain circumstances operating clearances in the push-pull control cables (used for pitch and roll control) can allow the transmission of rotor vibration to the control stick. Fitment of these clamps enables the clearance to be adjusted and the vibration reduced (See Fig 2).

5. Apply Loctite 243 to the second screw, attach to an allen key by means of a magnet and pass through the access hole into the clamp
6. Ensure clamps are fitted, and any cut cable ties replaced, such that the clamp components cannot rub or fret to the aircraft or other cables in the centre channel, or contact the aircraft body.
